ERDC/CHL TR-01-26

Impacts of Navigation Channel Maintenance Dredging on the Coastal Processes of Chatham, Massachusetts

Donald K. Stauble

September 2001

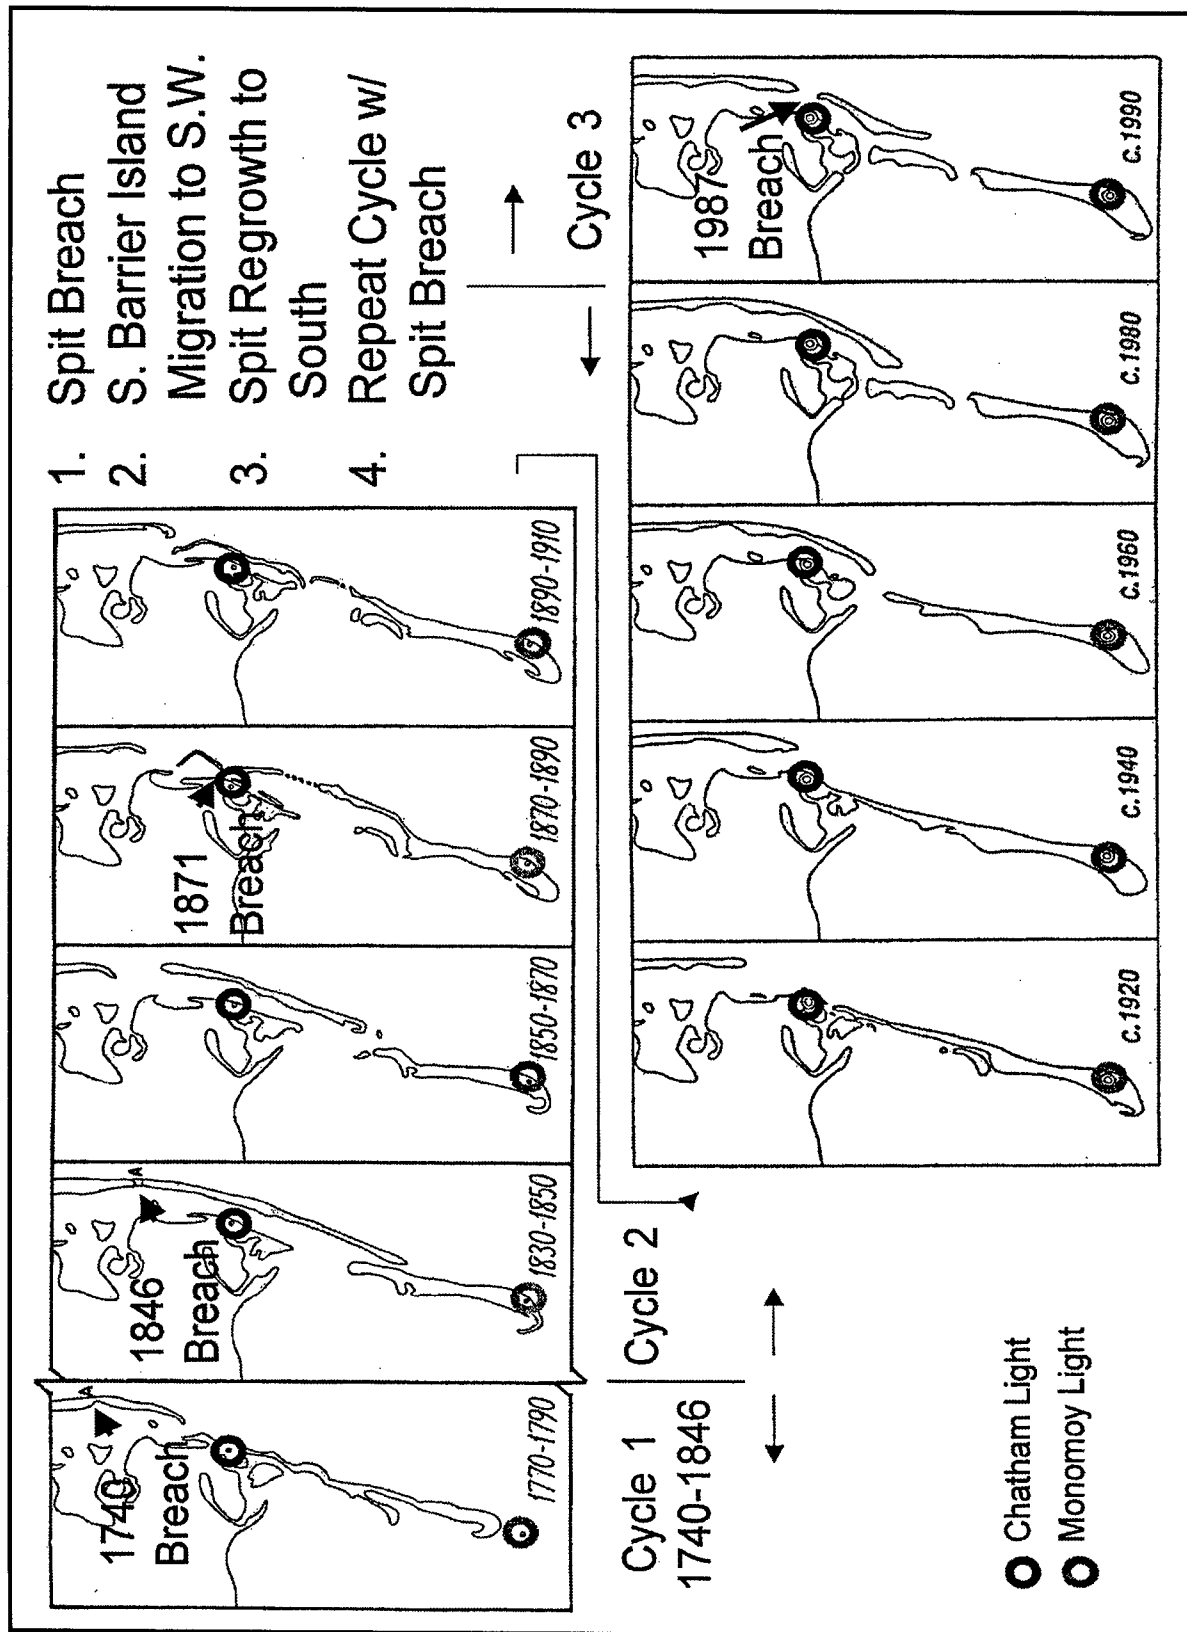
Figure 2. Cyclic change in Chatham shoreline since 1770s (after Giese 1988)

Historically, this barrier system has an approximate 140-year cycle of barrier spit growth and inlet formation (Giese 1988). The cycle starts with the growth of Nauset Spit southward from the mainland sea cliffs of Eastham and Wellfleet. The spit migrates southward with the prevailing longshore drift until a storm occurs and a breach breaks through a weak point in the barrier, creating a shortened spit and a detached barrier island from the southern portion of the spit. This southern barrier continues to migrate to the south and west and eventually welds to the mainland. Charts and other records dating back to the 1700s indicate that an inlet

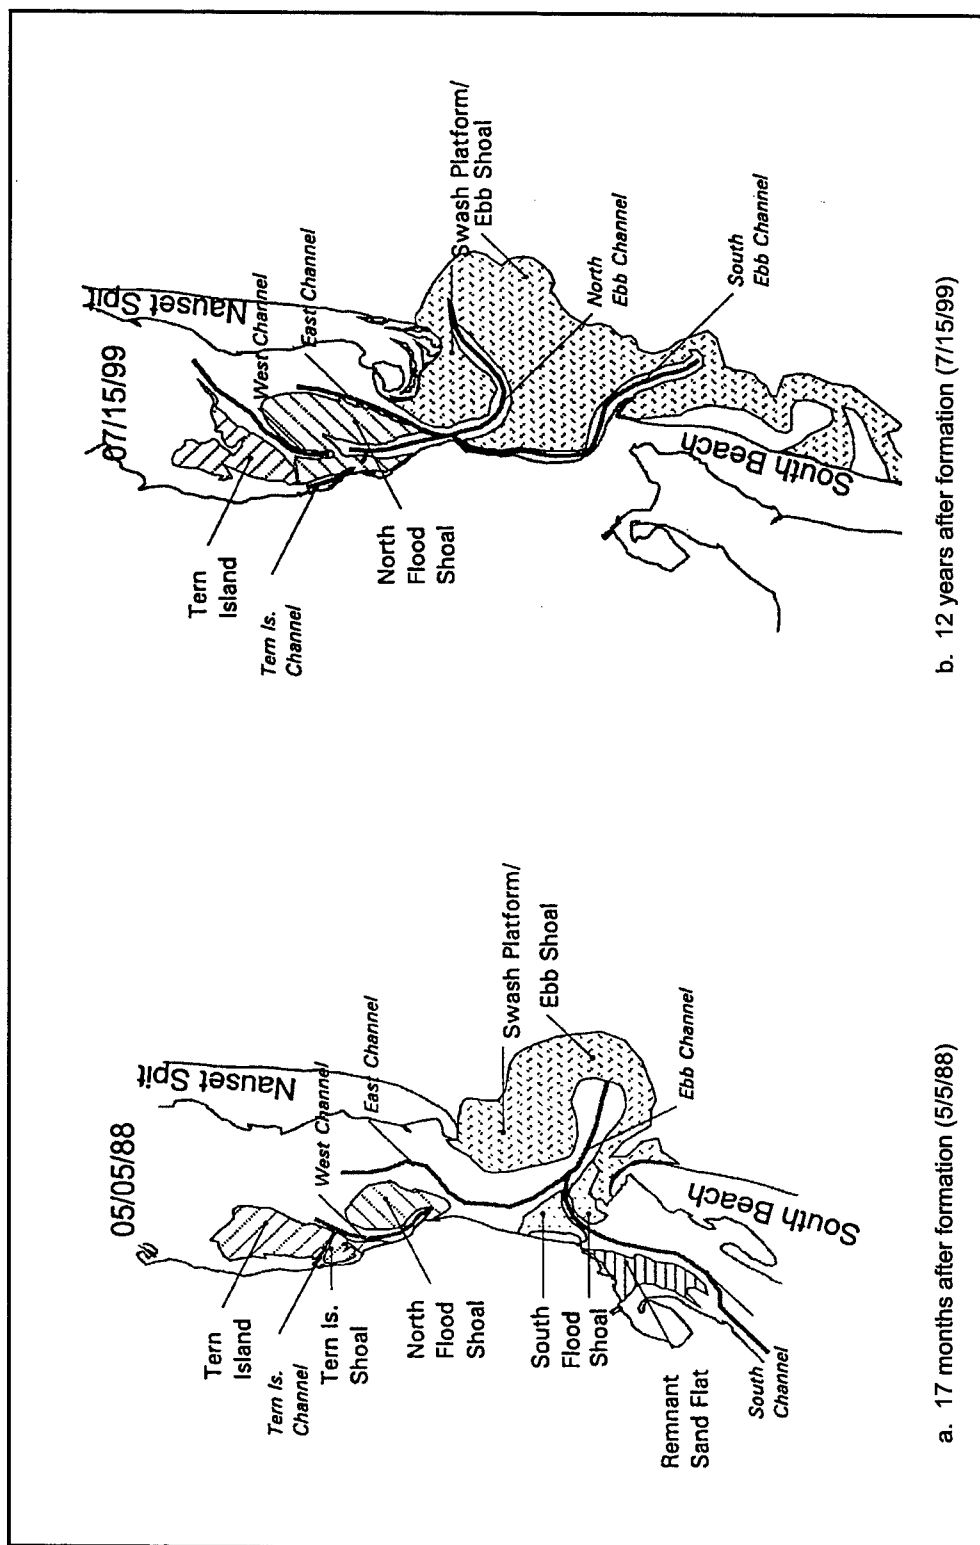
Figure 3. Morphologic features of the ebb and flood shoals, channel center line and shorelines associated with Chatham Inlet

Several shoals have been identified as the inlet has evolved and the number of shoals has changed as sediment has eroded and accreted with time. The outline of each shoal was digitized using the intertidal and subtidal boundary based on color change and bed forms visible on the photos. Water clarity is for the most part, good in this area, so the interface between the lighter color, shallow shoal and the

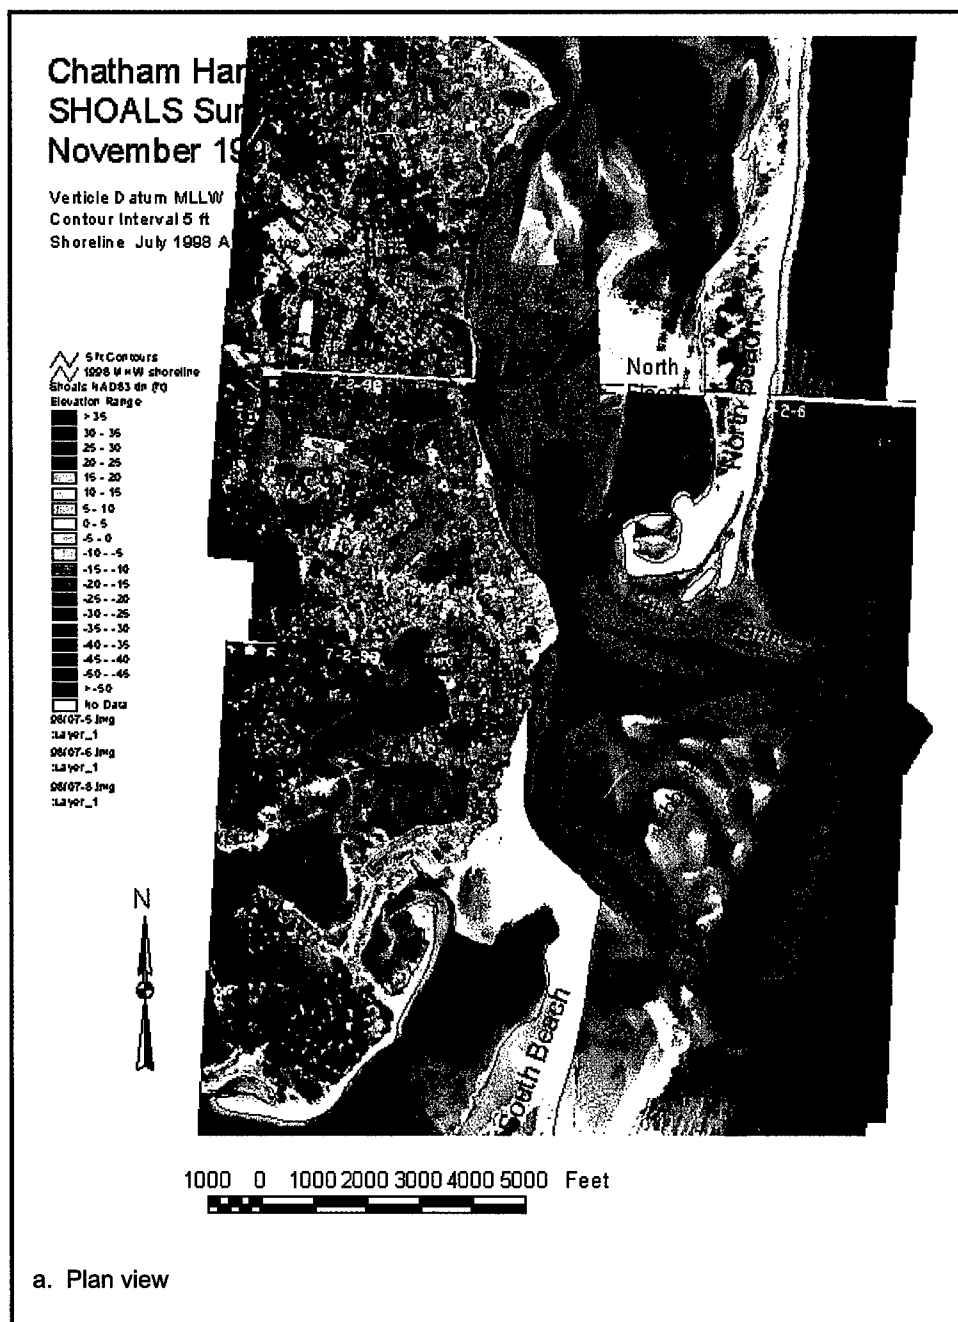
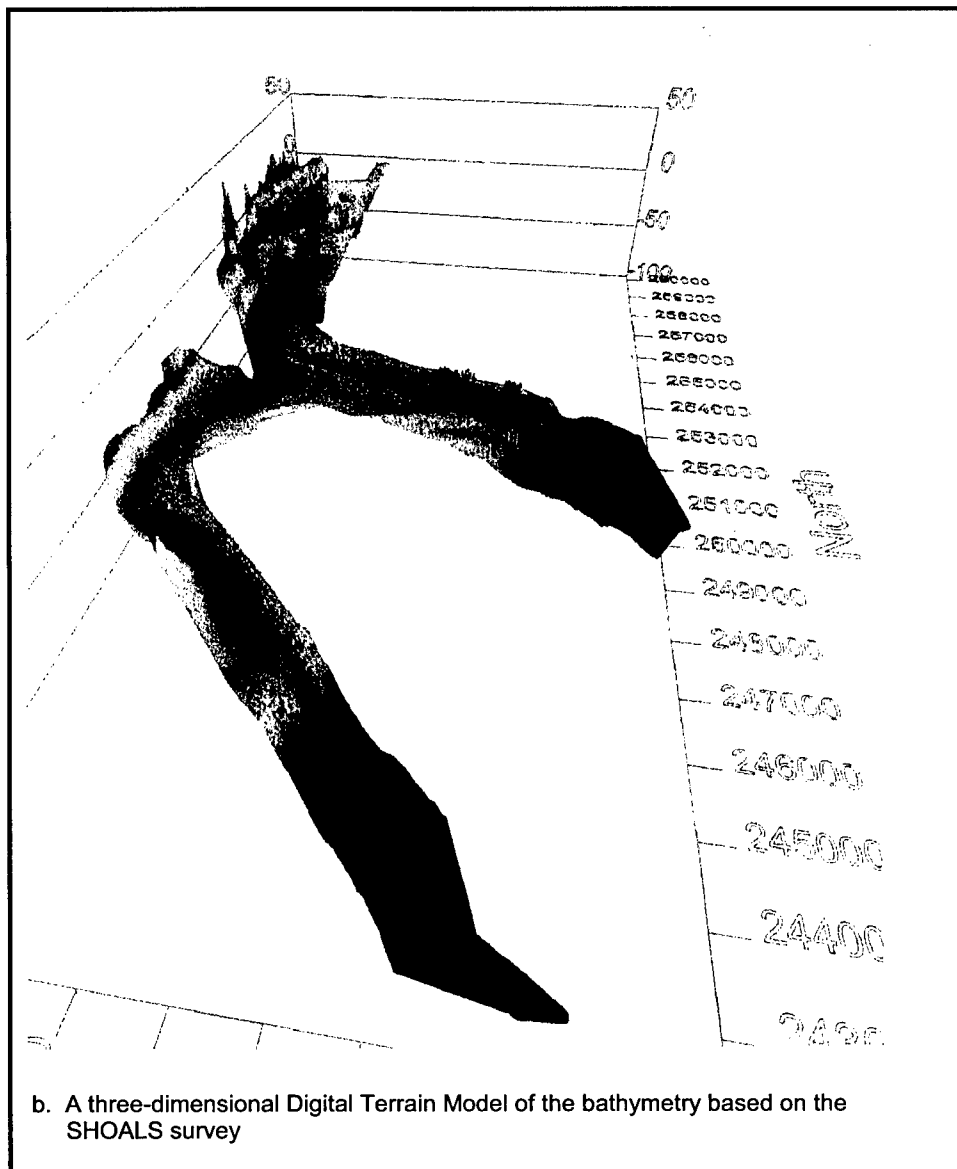
Figure 4. Bathymetry of portions of Chatham Inlet collected in November, 1987 by the SHOALS survey system (Continued)

Only one set of bathymetry was available for the area after the inlet was formed. A SHOALS survey was conducted in November 1998. The SHOALS system is described in Irish, Parson, and Lillycrop (1995). Due to limitations in the lidar system, the survey was limited to the ebb channels. Figure 4a shows a bathymetric map constructed from the SHOALS survey. The predominant south ebb channel and the incipient north channel are visible extending seaward through the ebb shoal as seen on a three-dimensional Digital Terrain Model (DTM) of the SHOALS data in Figure 4b. A large scour hole is prominent just to the bayside of the northern ebb channel. All depths are referenced to mean lower low water (mllw) on the SHOALS survey. Depths reaching to 29 ft (8.8 m) mllw in this scour area. The western side of the flood shoal is also visible showing the location of the west flood channel and the Tern Island channel. An ebb lobe is also present on the edge of the flood shoal where the west channel is trying to re-establish a continuous channel through the ebb shield on the western side of the flood shoal. A maximum depth of 54 ft (16.5 m) was recorded at the seaward end of the ebb shoal at the south ebb channel. Landward elevations reached a maximum height

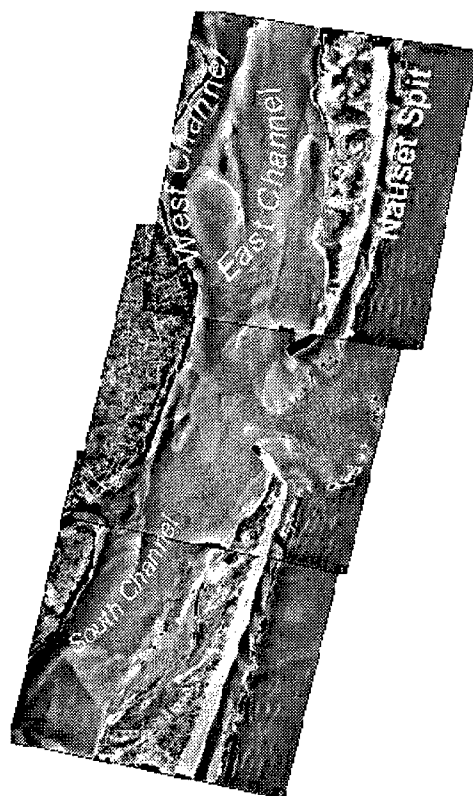
Figure 6. Postinlet morphology of Chatham Harbor, 7 May 1987

The first vertical aerial photography was flown five months after the breach, on 7 May 1987. Figure 6 shows the early stages of inlet development with the formation of an ebb shoal on the ocean side. At this time, the ebb shoal had a symmetrical crescent shape. A swash platform was beginning to form in the inlet throat just off the northern spit. A south flood shoal formed in the bay and encompassed the southern remnant shoal. Sand was also growing on the north flood shoal that had attached to the north remnant bay shoal. The main ebb channel

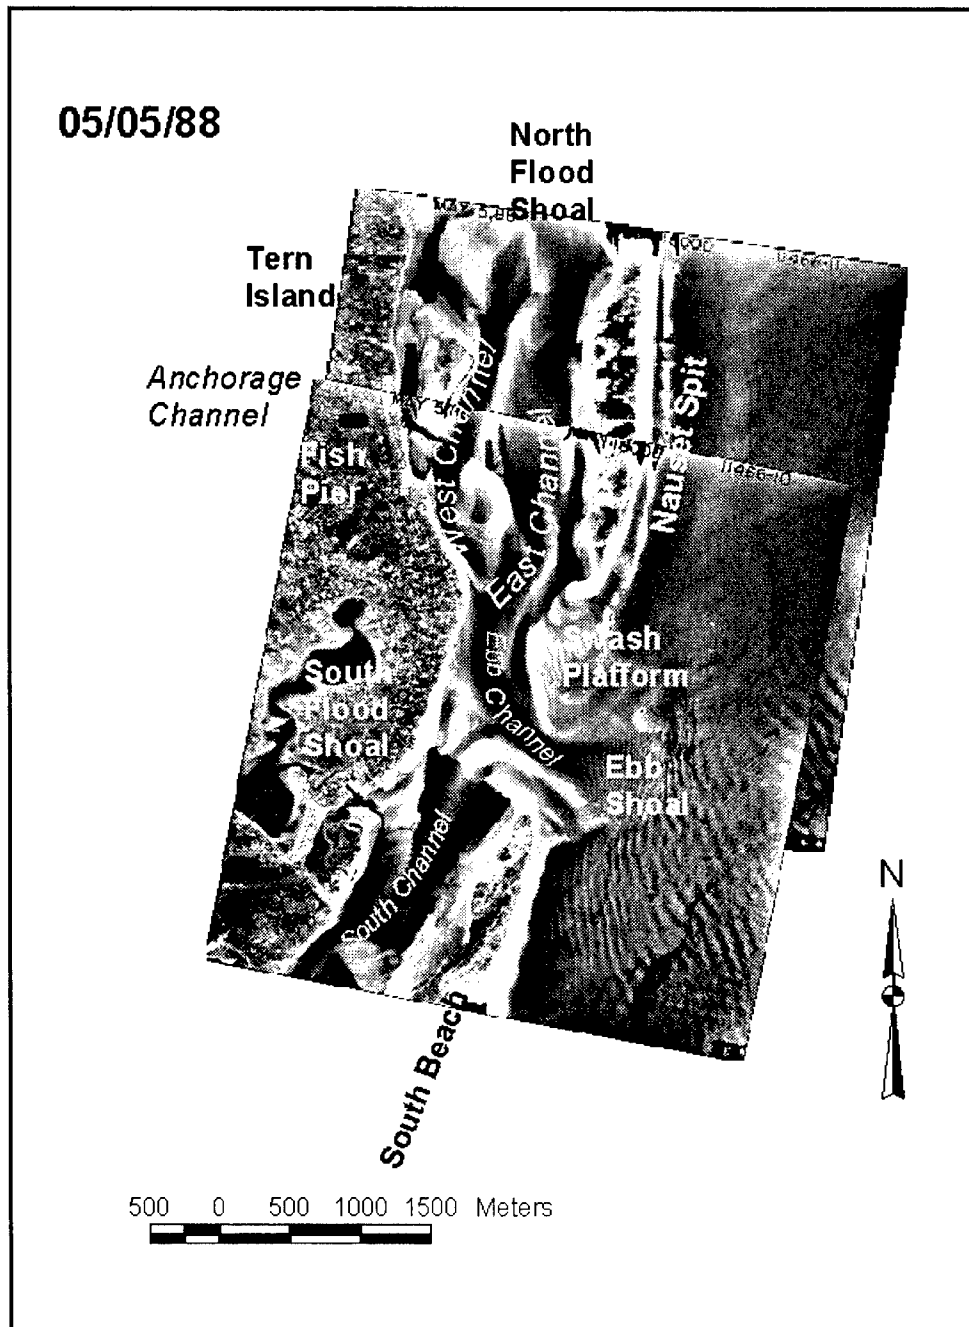
Figure 7. Morphology of Chatham Harbor, 5 May 1988

The north and south beach spits continued to recurve as the inlet throat widened. Figure 7 shows the inlet 17 months after formation on 5 May 1988. The main ebb channel had migrated to the south and the swash platform on the north end of the ebb shoal had enlarged. The north barrier spit had recurved north-westward into the bay. The south spit continued to recurve westward into the bay. The south beach spit had been described as having five cycles of spit evolution between 1987 and 1989, with spit elongation into the bay, narrowing of the spit and breaching of the spit end (Weidman and Ebert 1993). Sand from this breached spit end was incorporated into the complex south flood shoal sand body.

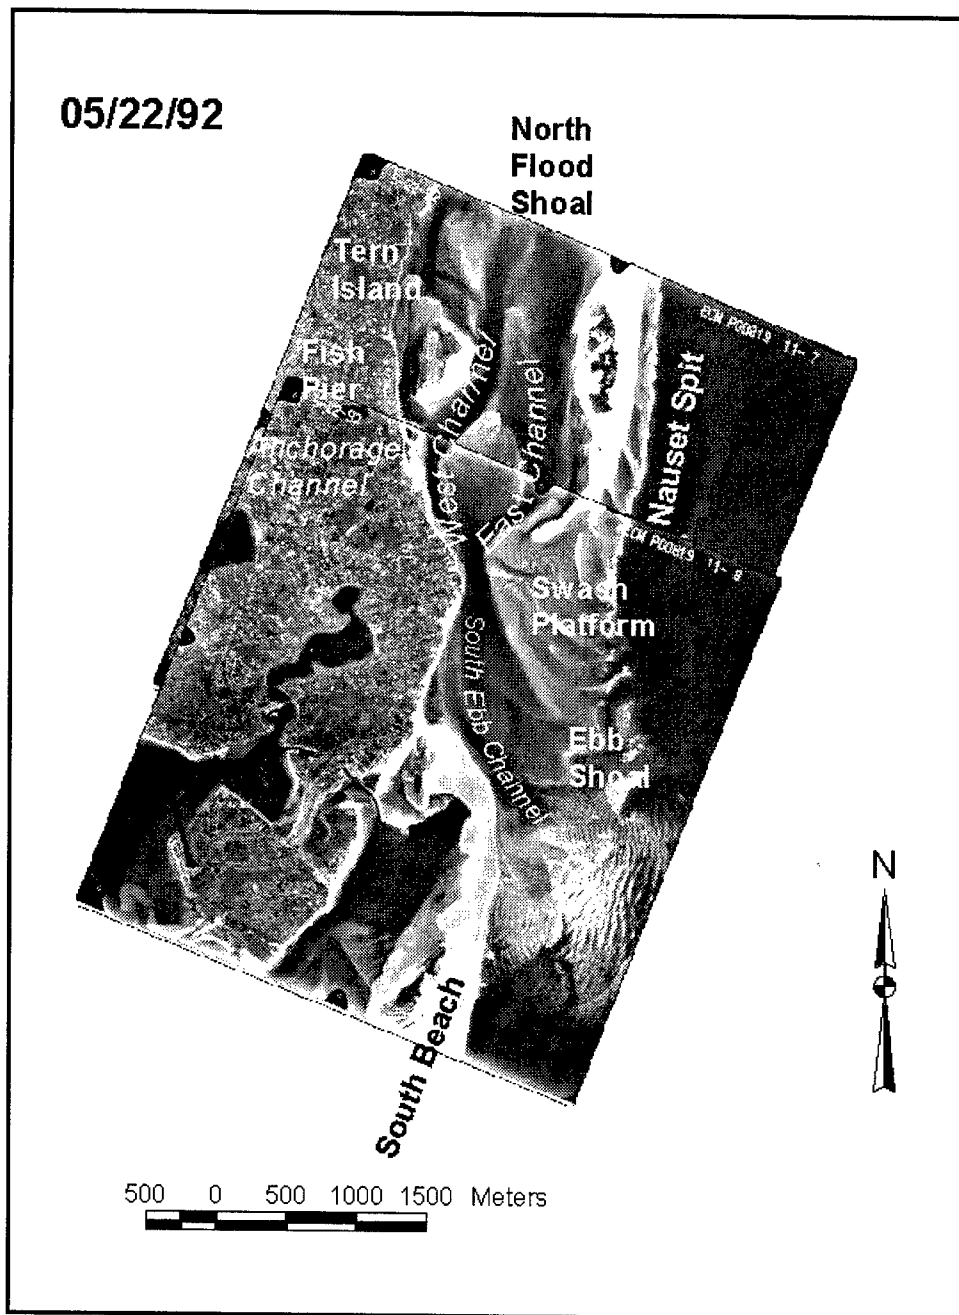
Figure 11. Morphology of Chatham Harbor, 22 May 1992, with south spit attachment to mainland beach

By 22 May 1992, the South Beach spit finally closed the opening to south Chatham Harbor, as it moved west and welded onto the mainland beach just to the south of the lighthouse (Figure 11). Now all of the tidal prism of north Chatham Harbor/Pleasant Bay flowed out the mouth of Chatham Inlet. Large ebb oriented shoals formed on the southern end of the swash platform, shoaling the main ebb channel. This main ebb channel curved from a southeast orientation inside the swash platform to a more east direction through the throat area. The Nauset Spit (North Beach) developed several finger spits off the ocean side and a large bar system graded into the swash platform. The spit and swash platform continued

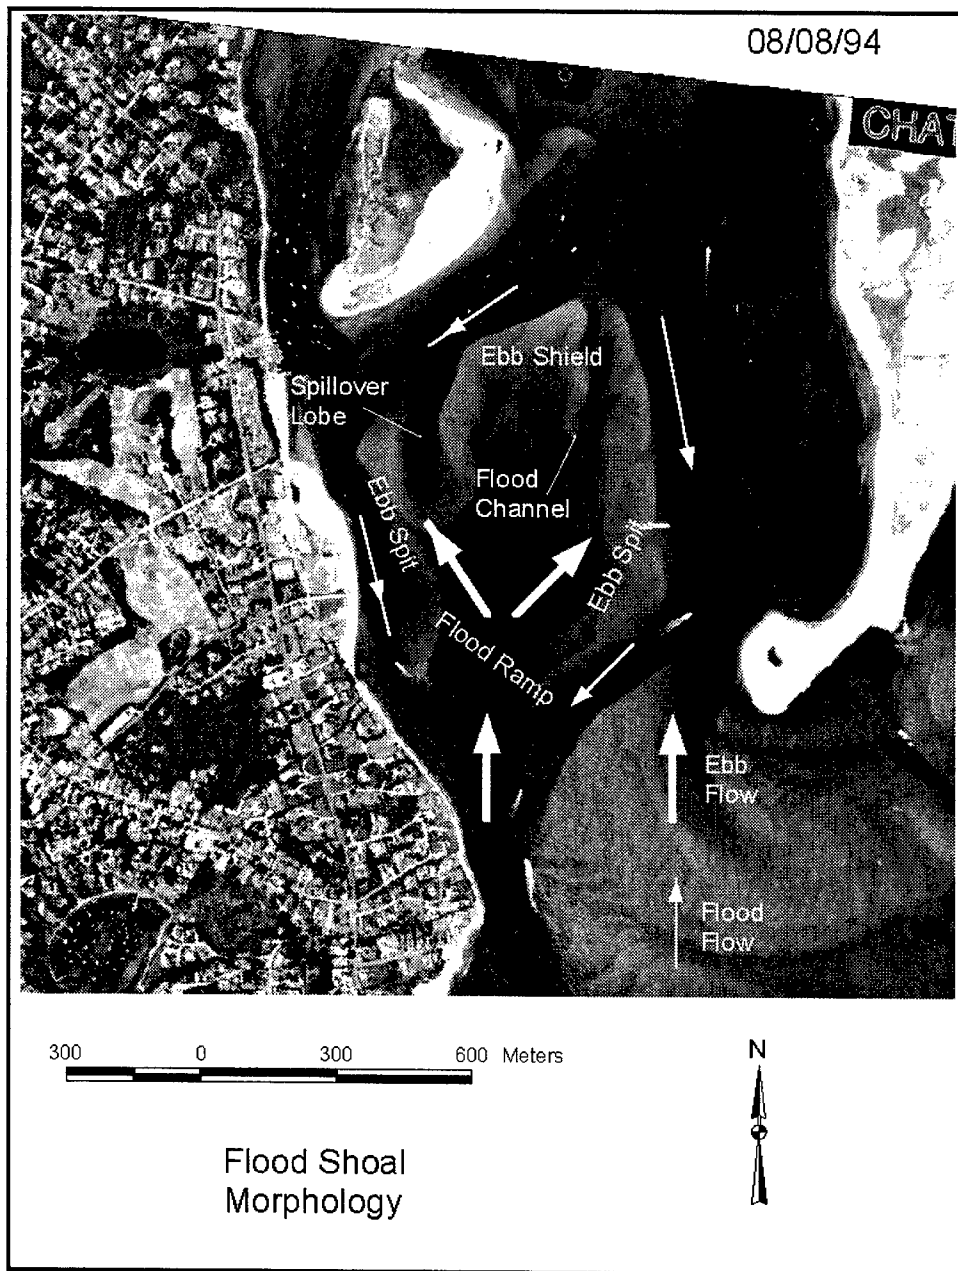
Figure 13. Morphology of the Chatham north flood shoal based on a model of Hayes (1975)

now large sand flat area (Figure 12). The north end of South Beach had by now migrated one island width toward the mainland. A small ebb oriented spit formed off the tip of the beach defining the south end of the ebb shoal. The main ebb channel was wide and oriented in a northwest-southeast direction, with the expanding swash platform dominating the north side of the ebb shoal. The north flood shoal expanded to the north and increased its width, taking on the classic flood shoal shape described by Hayes (1975) which includes a flood ramp, flood channels, ebb shield, ebb spits and spillover lobes (Figure 13). The west

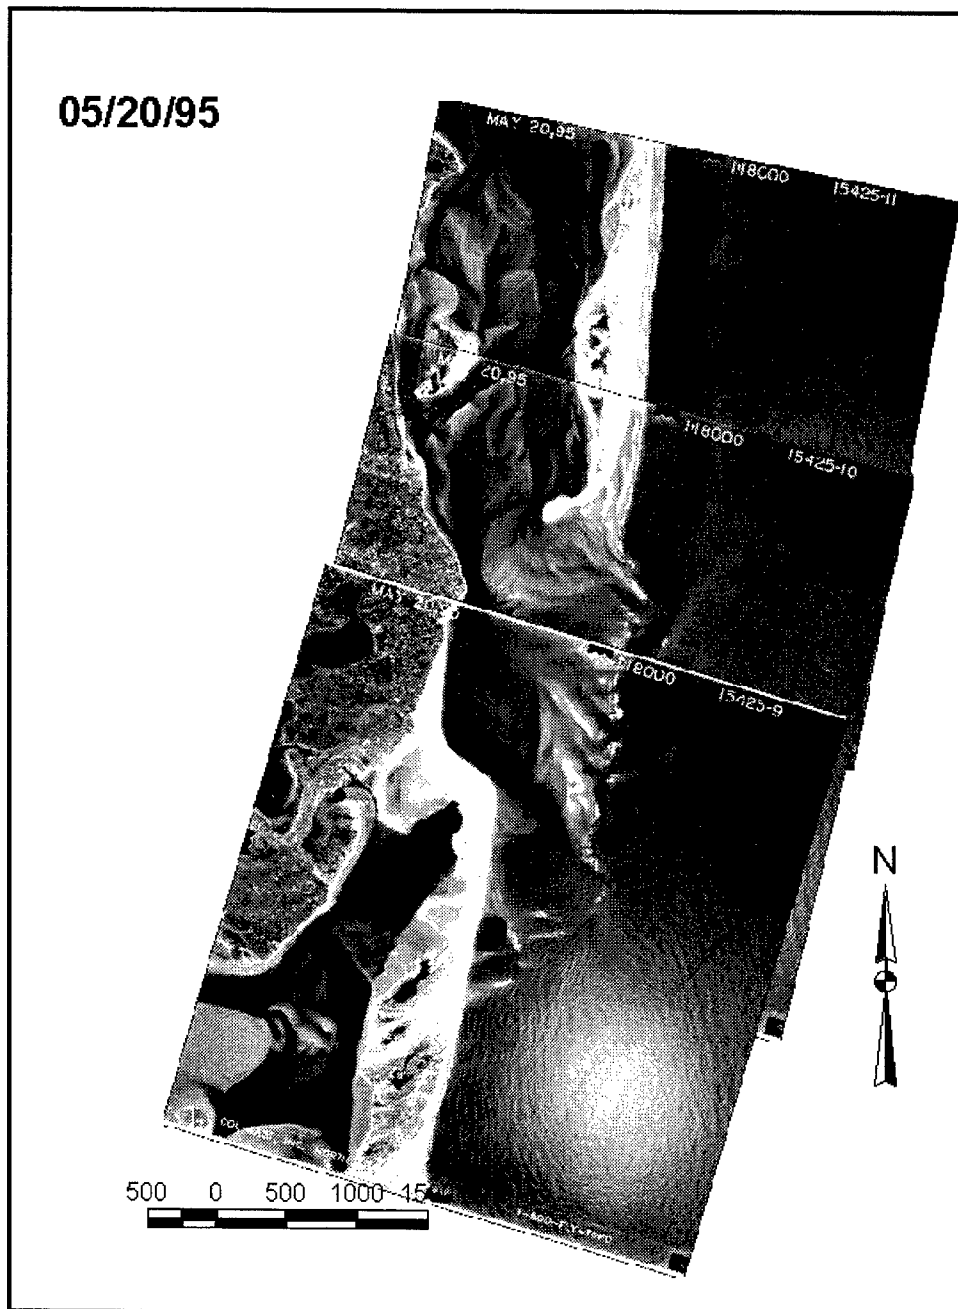
Figure 15. Morphology of Chatham Harbor, 20 May 1995, with two ebb channels

Eight years and five months after the inlet breach, the inlet was approximately 8,500 ft (2,600 m) wide. The main ebb channel had migrated to the extreme south end of the inlet and was against the South Beach shoreline in the 20 May 1995 photographs (Figure 15). A second ebb channel was beginning to form around 1,000 ft (304.8 m) north of the initial breach. The ebb shoal was divided into three parts with a smaller north swash platform, central ebb platform, and a southern ebb platform. The terminal lobe of the ebb channel was south of the north end of South Beach as the shoal took on an extreme asymmetrical shape to the south. The South Beach continued to migrate landward, but did not move further to the

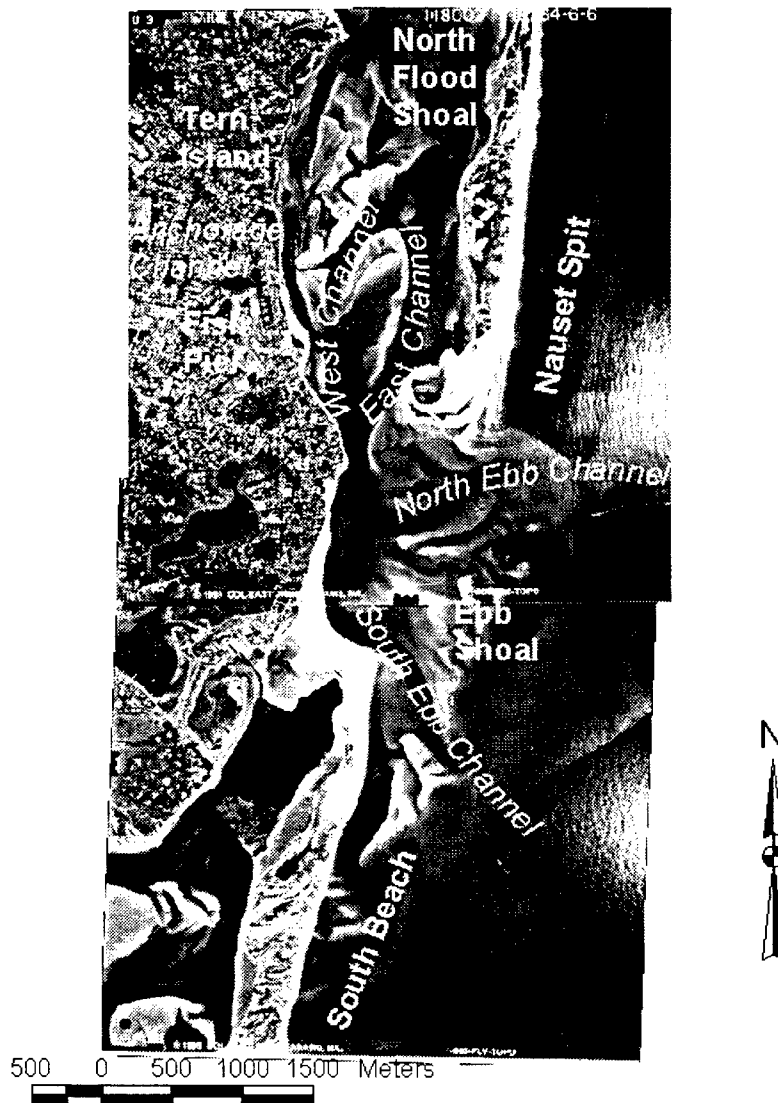
Figure 19. Morphology of Chatham Harbor, 15 July 1999

Twelve years after the initial breach, Chatham Inlet has still retained a highly dynamic morphology. Figure 19 shows the inlet as of 15 July 1999. The linear shoals continue to gain sand on the expanding ebb shoal. With the increasing dominance of the meandering northern ebb channel, the ebb shoal is expanding seaward on the north end. At the same time it is migrating further to the south, creating substantial shoals and making navigation through the southern ebb channel a challenge. A new ebb-orientated spit has formed at the tip of South Beach. The south channel has been pushed against the mainland shore as the ebb

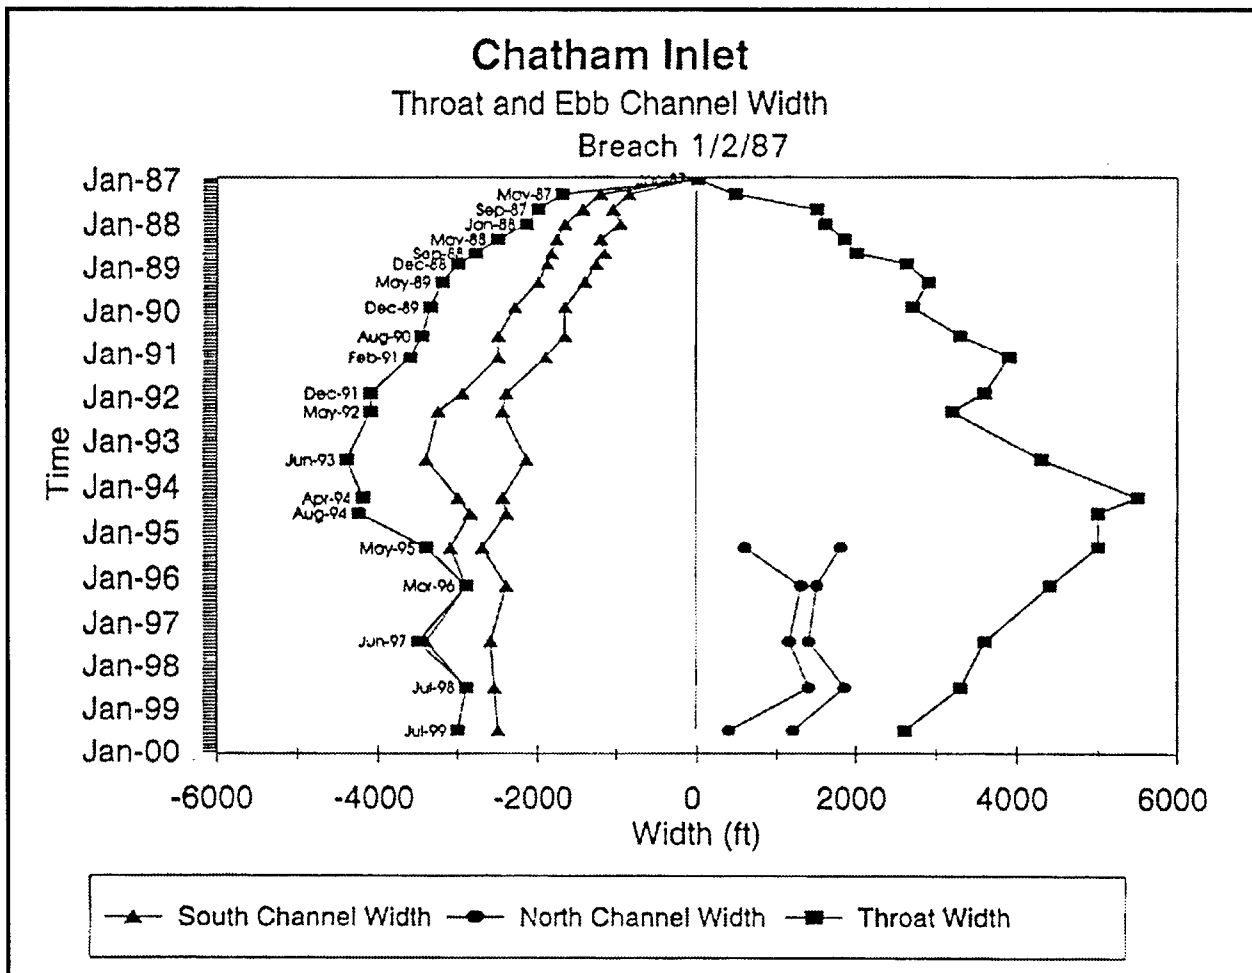
Figure 20. Temporal change in inlet throat width and position of ebb channels with respect to original beach location

Changes to the throat section between the adjacent beaches and the position of the ebb channels was quantified by measuring the distance along a common line drawn along the axis of Nauset Spit between the edge of the north and south spits off of each yearly photo set. The width of the ebb channels was also measured where each side of the channel crosses this reference line. A zero point was taken at the site of the original breach. Figure 20 plots the inlet-throat width and channel positions, which were updated from Liu et al. (1993). The distance between the

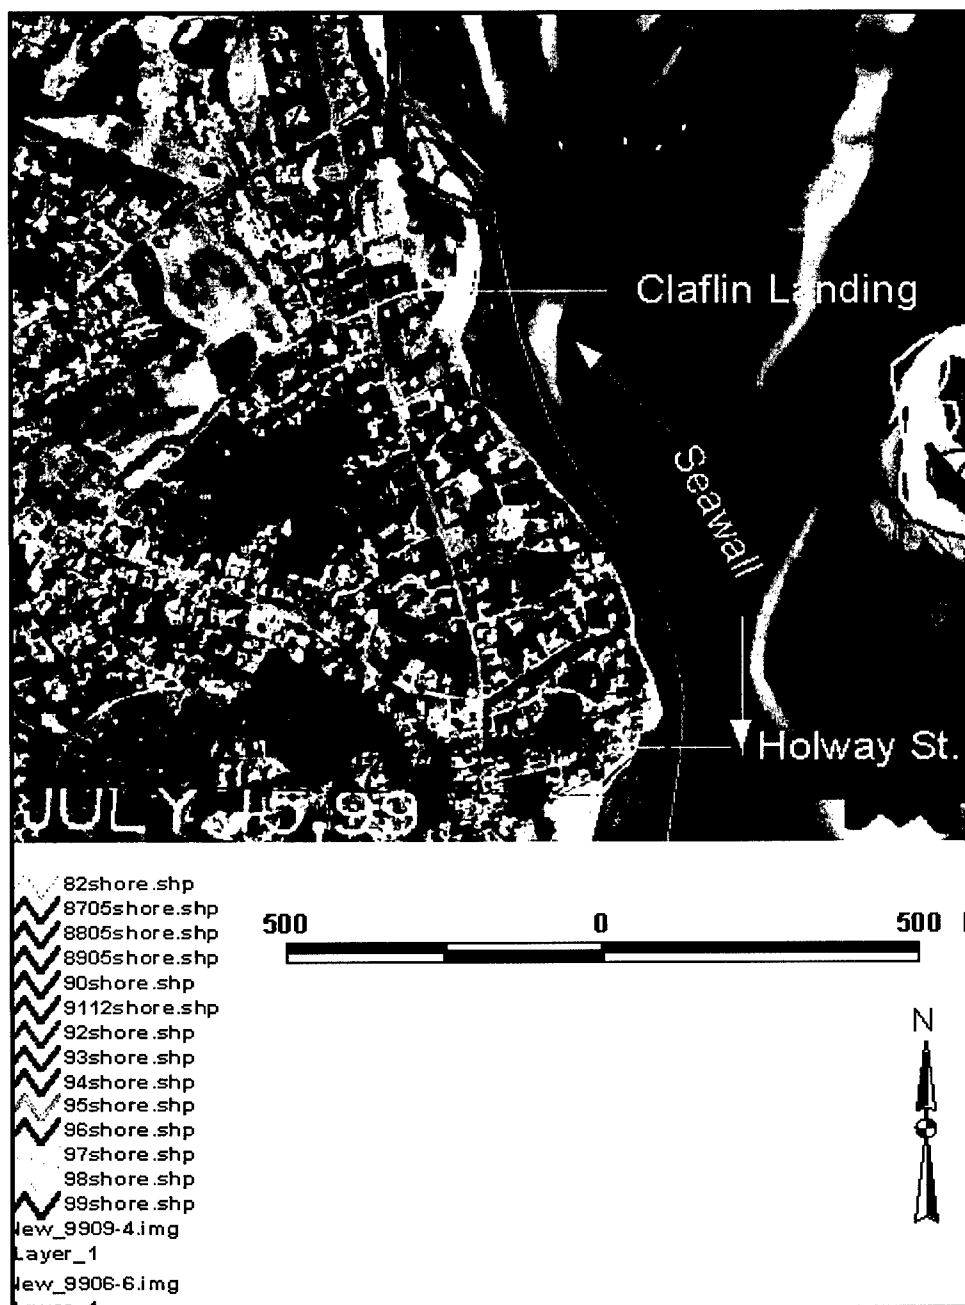
Figure 23. Mainland shoreline change in seawall area (Claflin Landing to Holway Street)

Figure 23 shows the mainland shoreline change from preinlet 1982, where the shoreline was from 100 to 300 ft (30.5 to 91.4 m) further seaward. As the inlet

was opening, after 1987, the shoreline maintained a wide low tide beach along this stretch of shore that formed a point into Chatham Harbor through 1989. As Nauset Spit moved north and west the inlet throat expanded and allowed waves and stronger tidal currents to directly encroach upon this shoreline. A stone revetment was constructed during the winter of 1987-1988 to protect the upland property as the shoreline began to erode almost immediately after the inlet opened and some houses were damaged or completely destroyed. Erosion in front of the structure continued through 1989, and the revetment was enlarged and strengthened between 1989 to 1990 after being overtopped by storm waves. By 1990 the beach

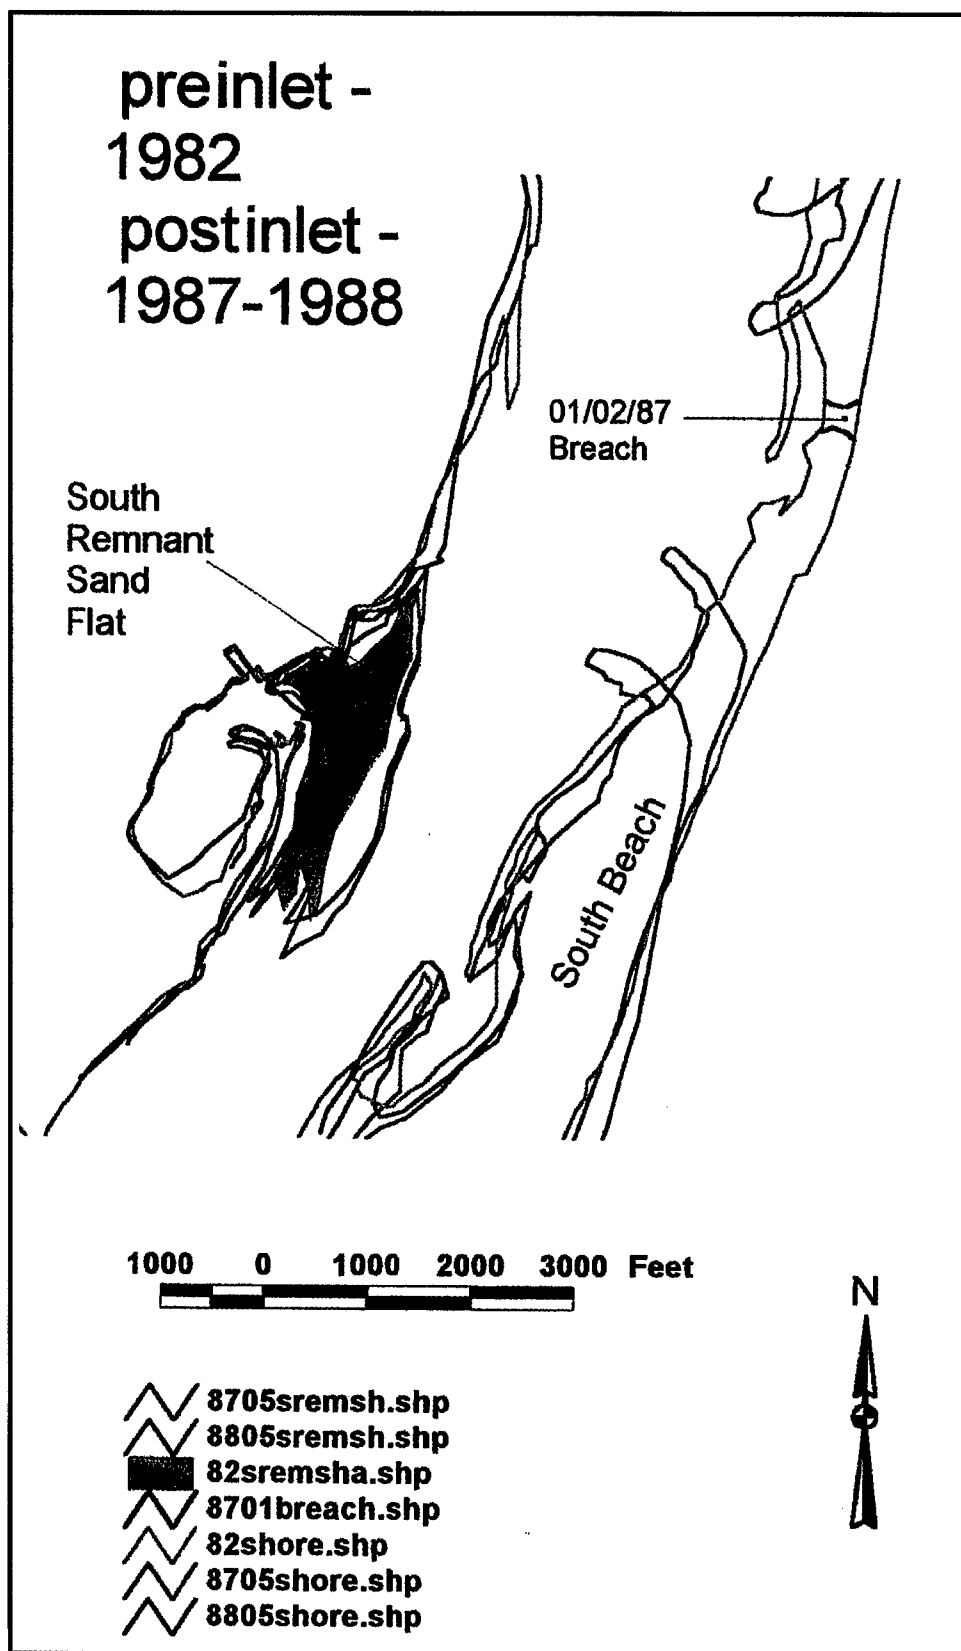
Figure 38. Map of area change in remnant south sand flat. Solid area shows pre-inlet remnant shoal incorporated into the remnant south sand flat

Another preinlet shoal was located south of Chatham Lighthouse near a marina entrance and the spit to Morris Island. Figure 38 shows the location of the remnant south sand flat relative to the south remnant shoal/south flood shoal

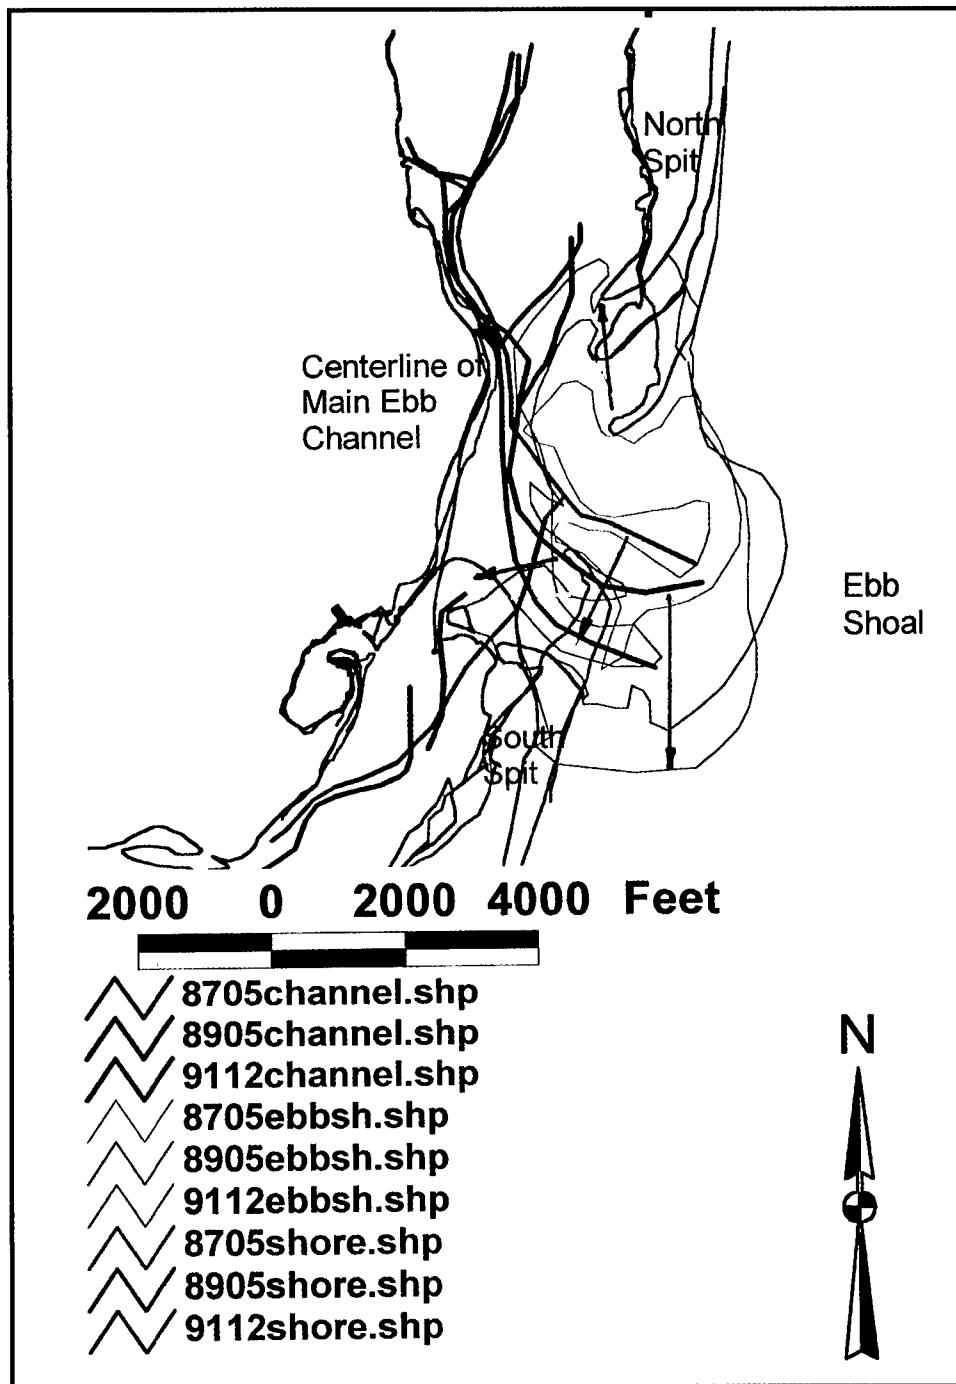
Figure 47. Net changes in main ebb channel, ebb shoal edge, and north and south spits from 1987 to 1991

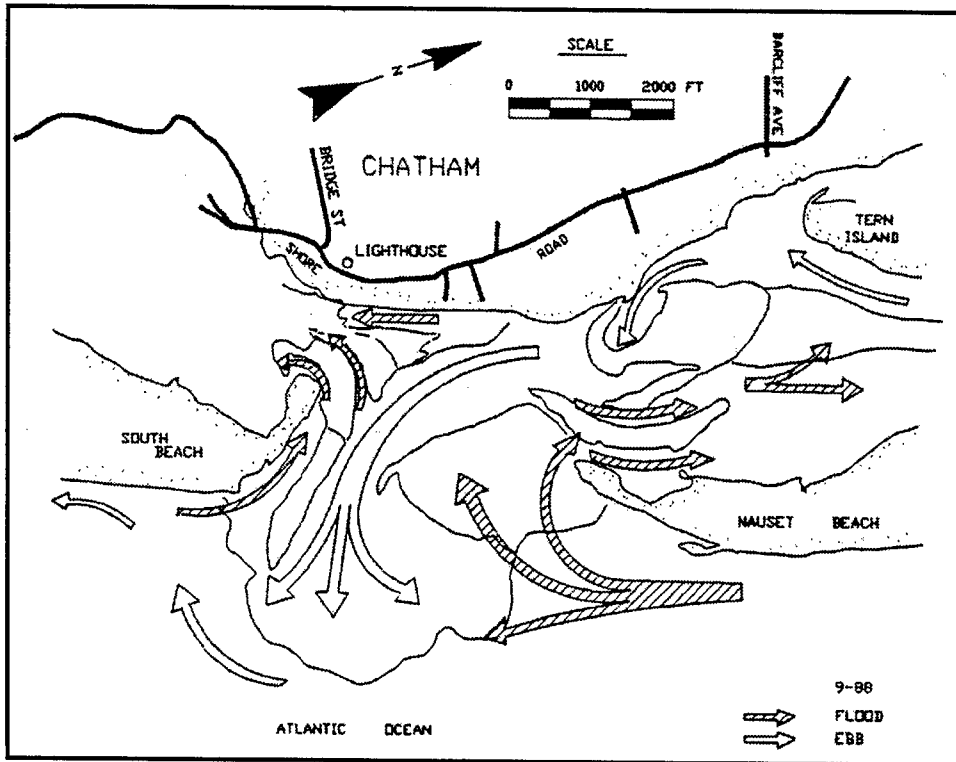
Figure 48. Sediment transport pathways at Chatham Inlet based on morphology from September 1988 (Liu et al. 1993)

A similar pattern of flood flow over the swash platform transports sand into the northern Chatham Harbor. Sand is transported onto the flood tidal shoal, and up the east and west flood channels. Ebb tidal currents move sand out of the harbor, basically, in the east and west tidal channels into the main ebb channel and out onto the ebb shoal. At this time the South Beach spit had almost attached to the mainland beach with predominantly flood flow through the gap and prevented much tidal flow and sediment transport interchange with south Chatham Harbor.

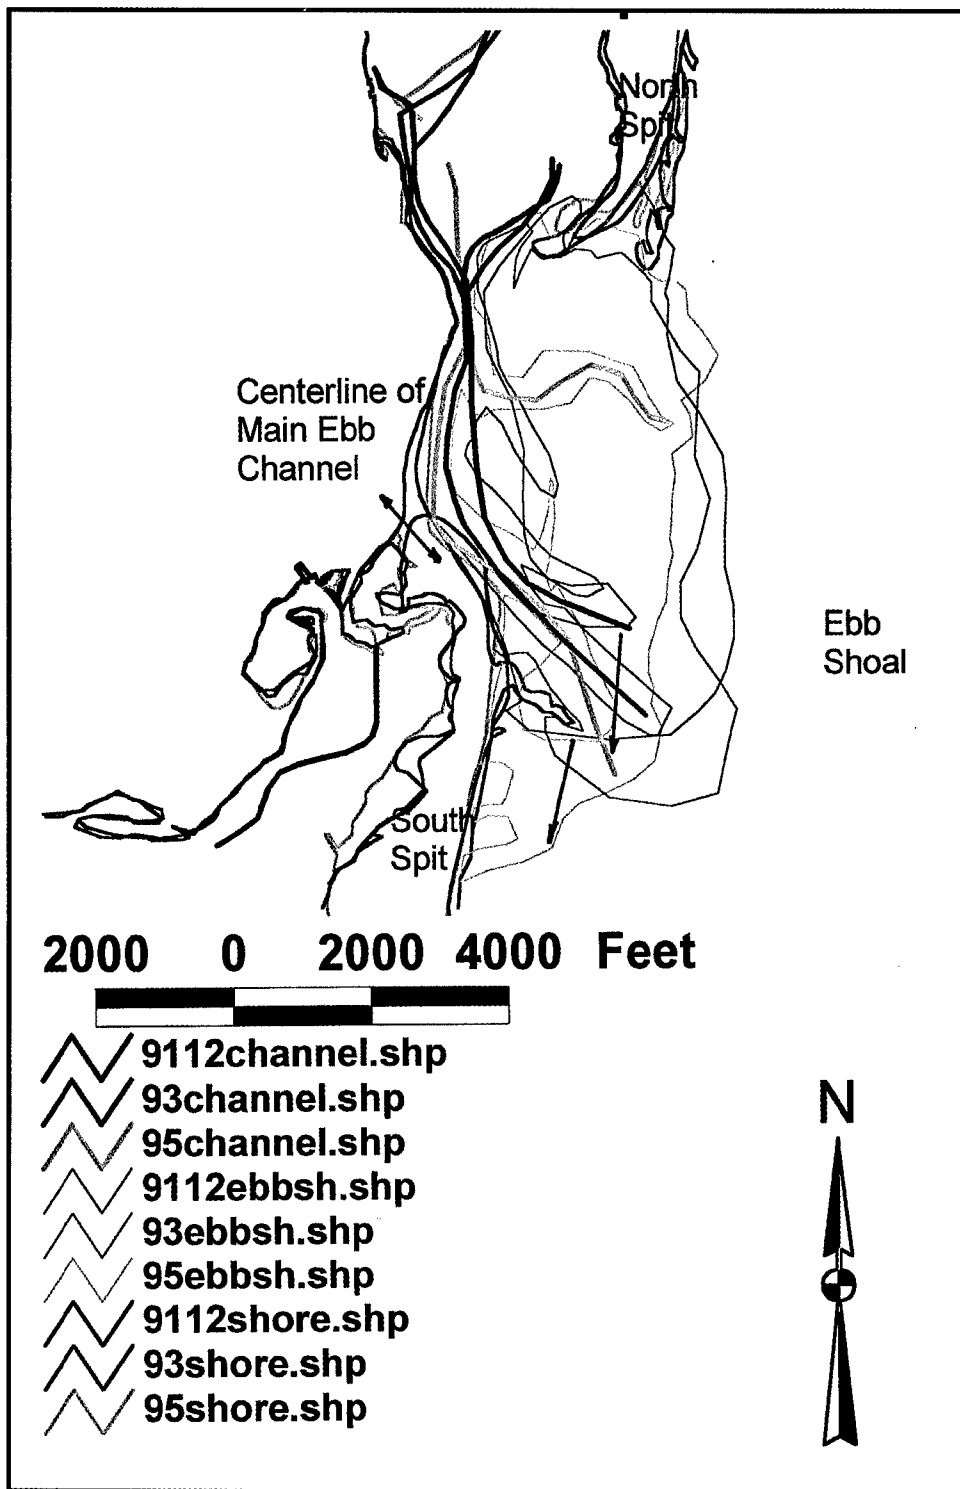
Figure 50. Net changes in main ebb channel, ebb shoal edge, and north and south spits from 1991 to 1995

With the welding of South Beach to the mainland in 1992, the circulation and predominant sediment transport was restricted to north Chatham Harbor and Pleasant Bay. Net changes in the main ebb channel, ebb shoal edge, and north and south spits from 1991 to 1995 are summarized in Figure 50. The ebb shoal
